Free-Piston Stirling Engine/ Linear Alternator 1000-Hour Endurance Test

Jeffrey Rauch and George Dochat
Mechanical Technology Incorporated

March 1985

Prepared for
NATIONAL AERONAUTICS AND SPACE ADMINISTRATION
Lewis Research Center
Under Contract DEN 3-333

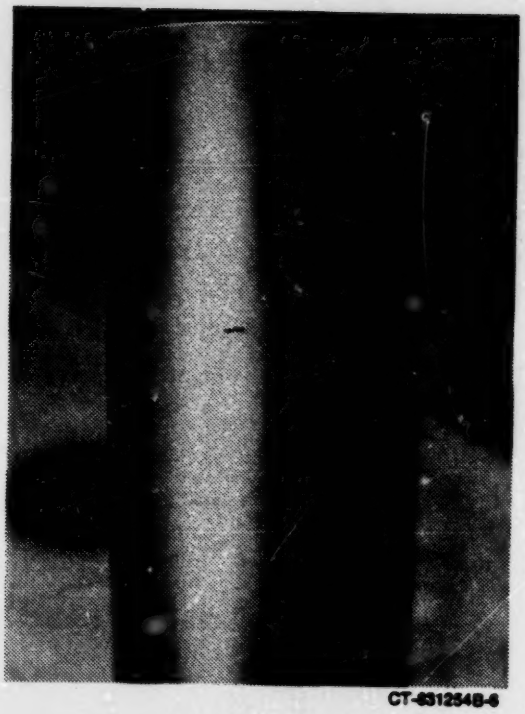
2. After the completion of the full-stroke test, the engine was being run to repeat selected test point performance. Due to an operator error, the engine was run for approximately three minutes (~10000 cycles) without the hydrostatic gas bearings operating before the error was noticed and the engine shutdown. The subsequent inspection showed a number of local scratches, attributed to the dry-bearing operation, on the power piston (Figure 3-2) and mating bearing. The depth of the local scratches were not measurable by conventional instruments (micrometers); the surface profile (Figure 3-3) was measured in the areas shown in Figure 3-4 with a surface analyzer. Further, the bearing flow rate increased less than 10%

Figure 3-2 Piston Rub Due to
Dry Bearing Operation

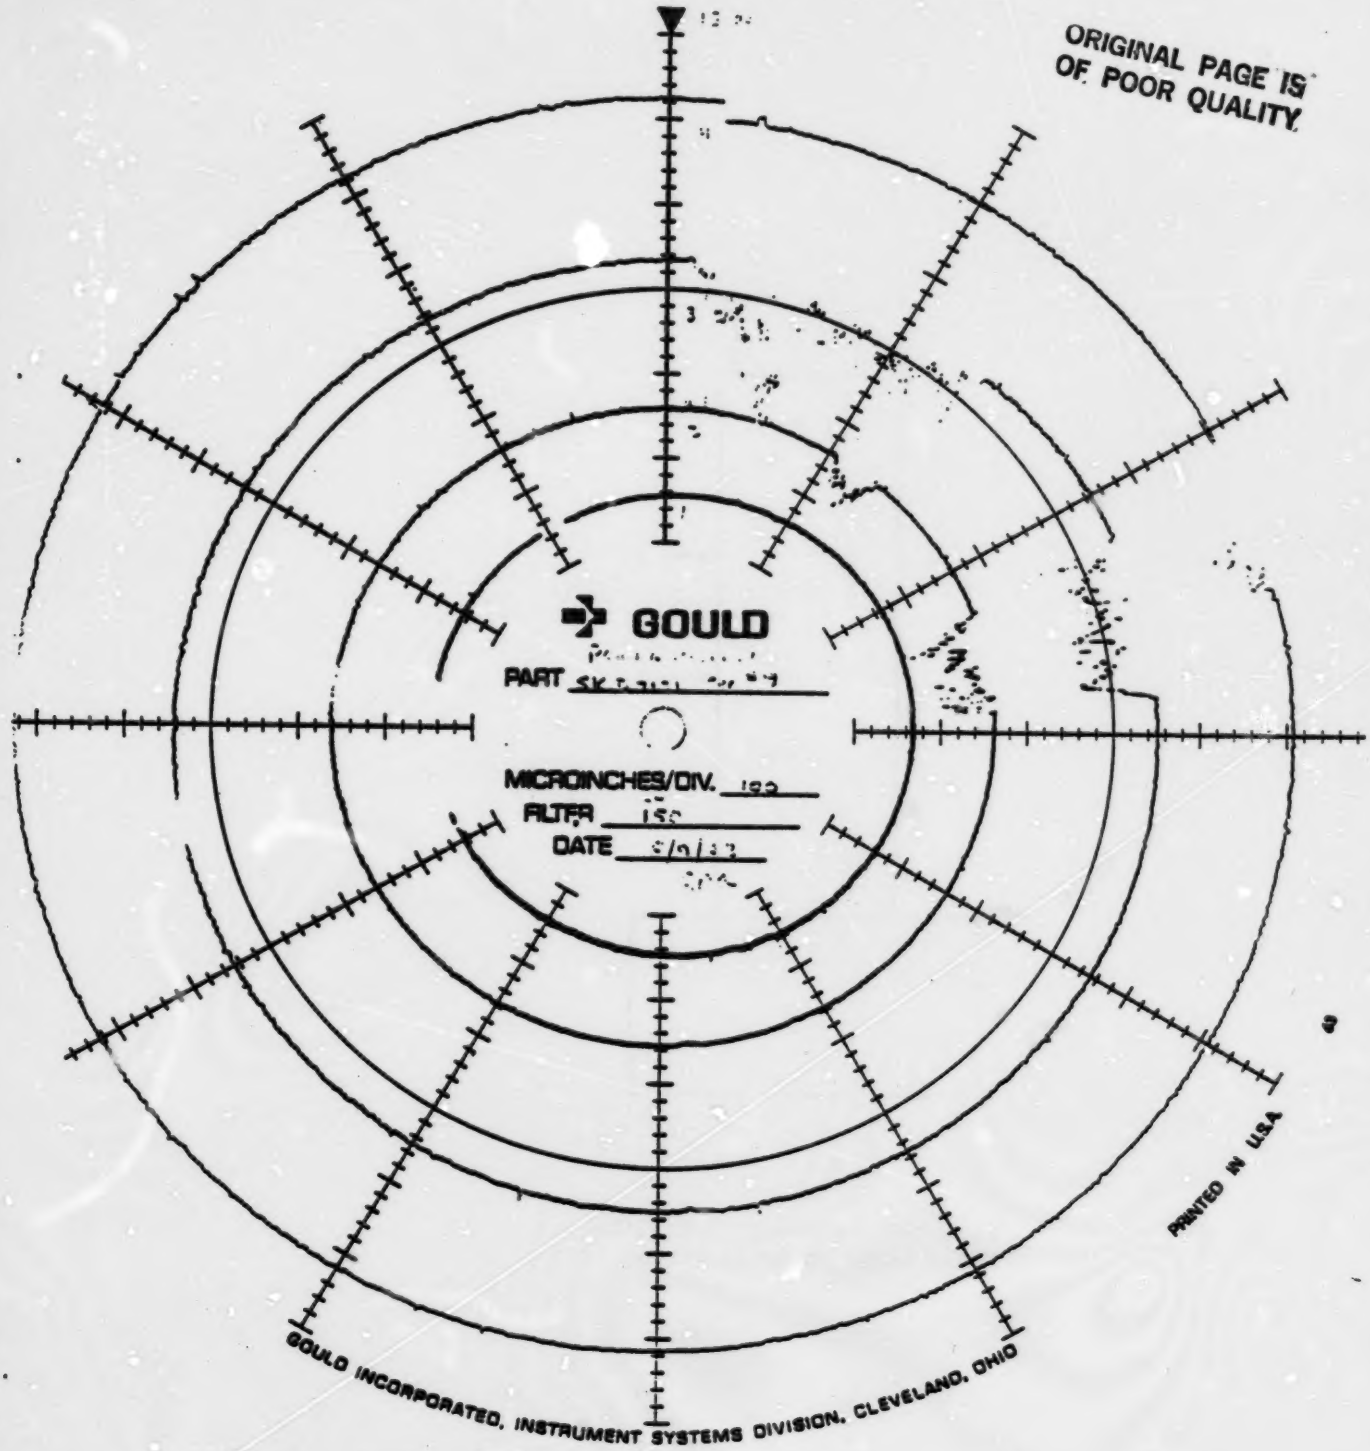
Figure 3-3 Surface Profile After Dry Bearing Operation

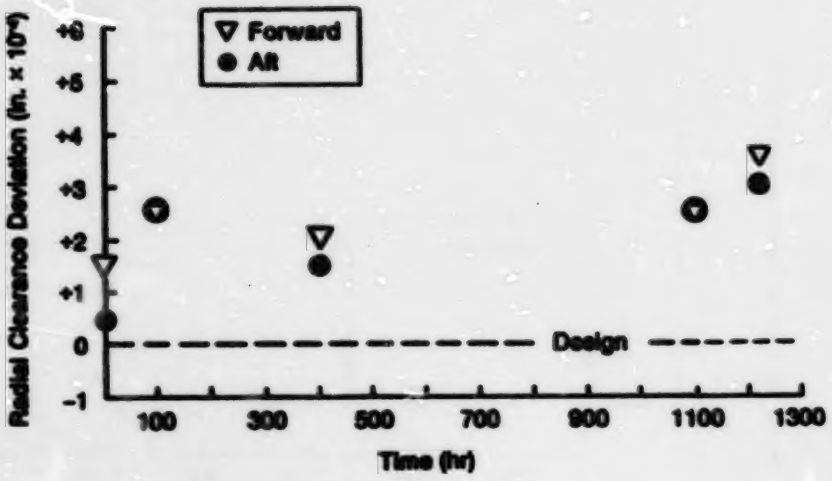
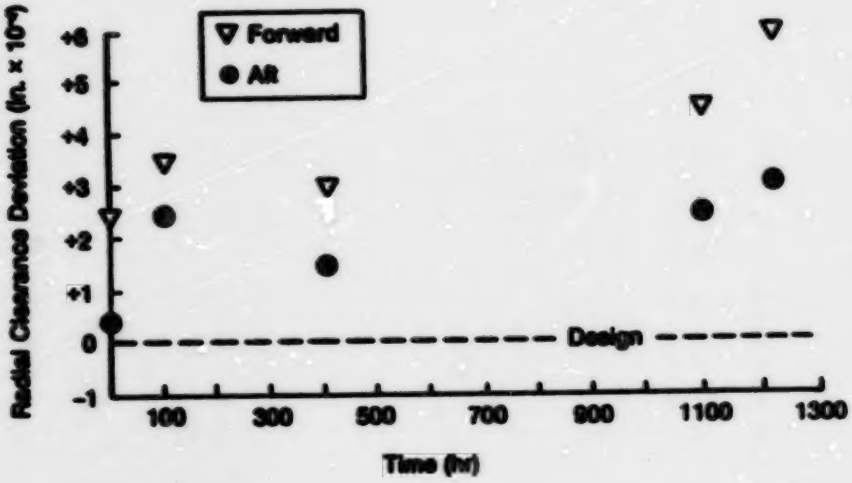
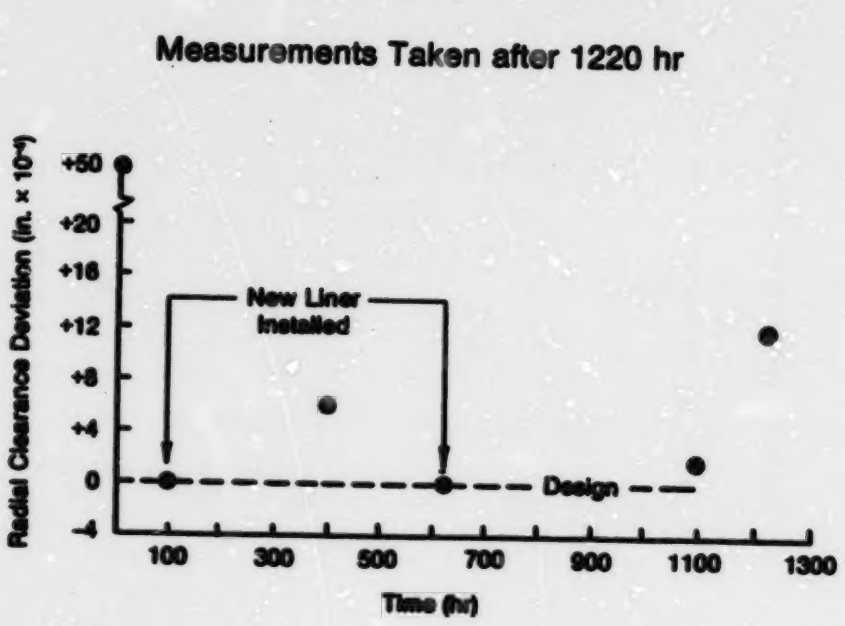
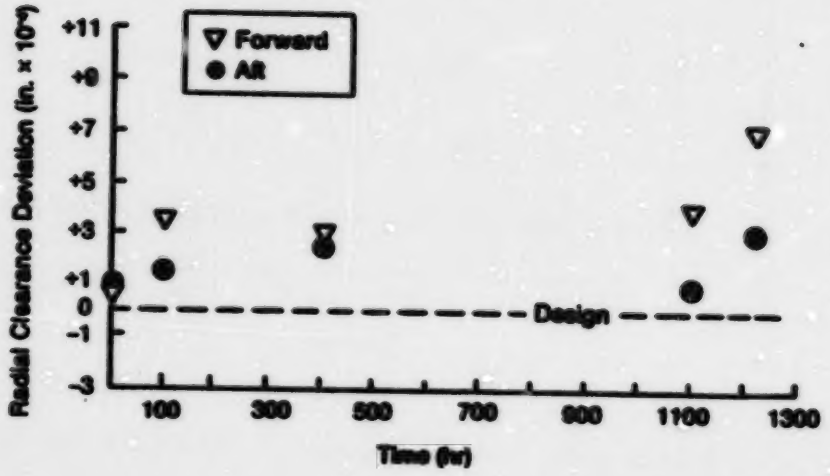
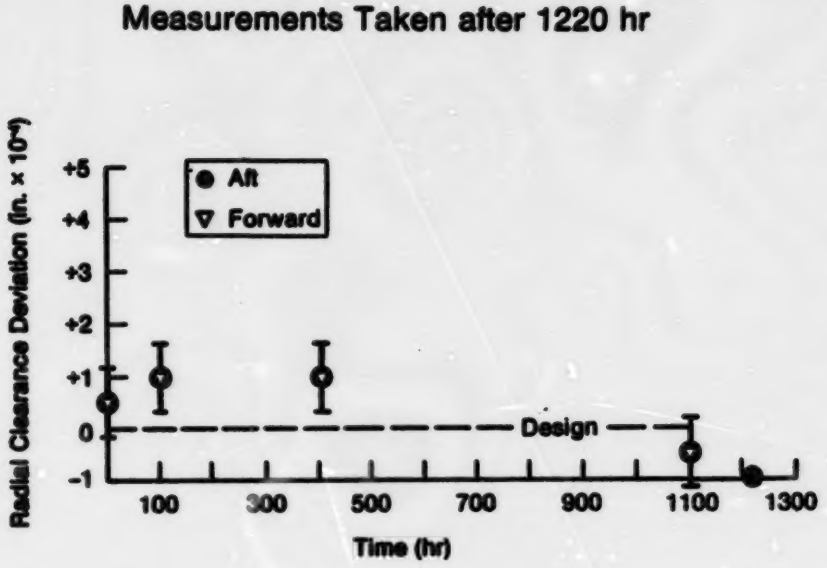
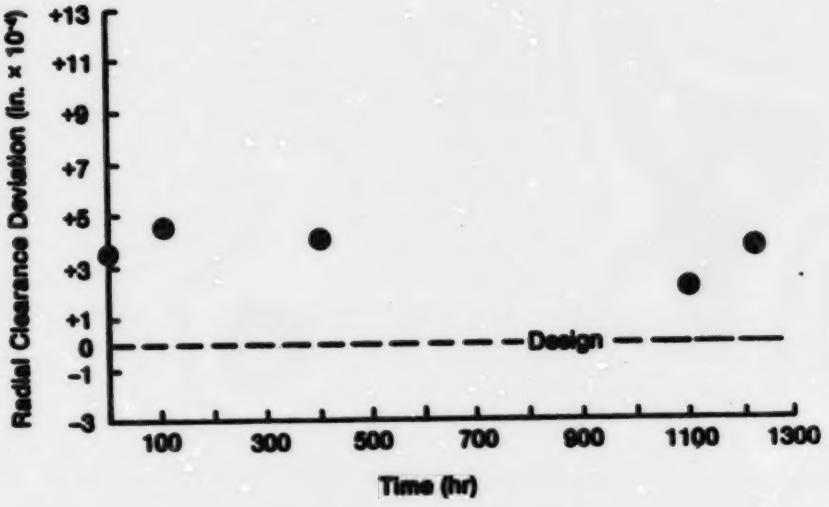
Measurements Taken after 1220 hr

The pre- and post-test inspections showed some clearance changes. Figures 3-10 through 3-15 indicate the clearance change between the initial inspection (No. 1) and the inspection at the end of 100 hours (No. 3). Table 4-2 summarizes these particular measurements. Most of the clearance changes were on the order of the measurement resolution. The displacer forward and aft bearing clearance, forward displacer gas spring clearance, and displacer bearing seal, however, appear to be significant. The motor clearance seal actually decreased during the test, which may be due to shrinkage of the phenolic liner. There was some heat discoloration of the liner. The increase in the displacer bearing clearance is not substantiated by the bearing flow check, which indicated a slight decrease in clearance. The other clearances, while significant, could not be checked against independent measurements. These would tend to increase the respective gas spring losses and, consequently, displacer motor power. However, displacer motor power and respective gas spring measured losses only increased slightly during the 100-hour test.

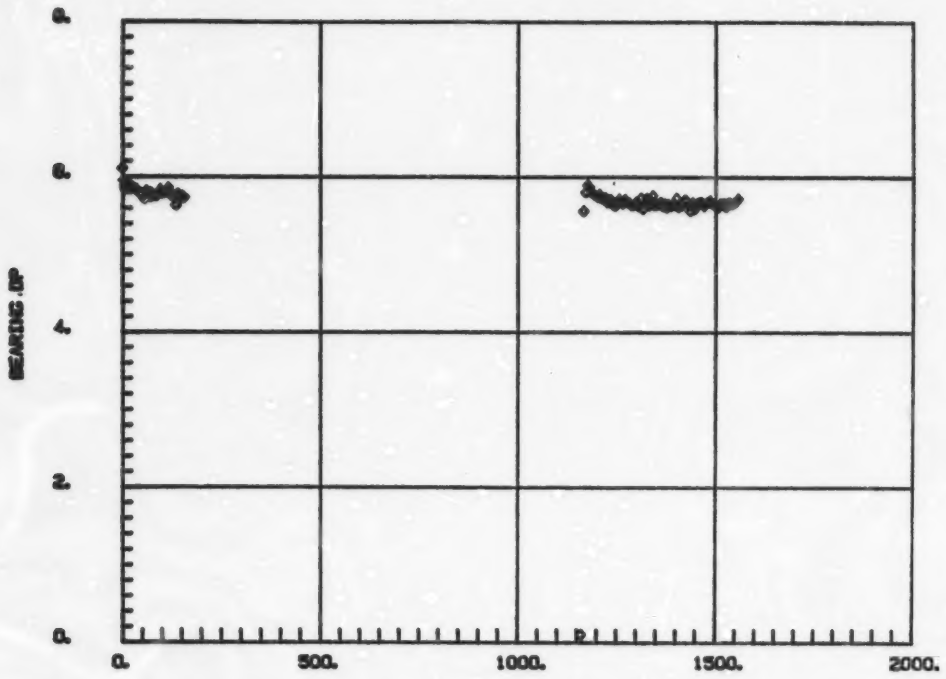
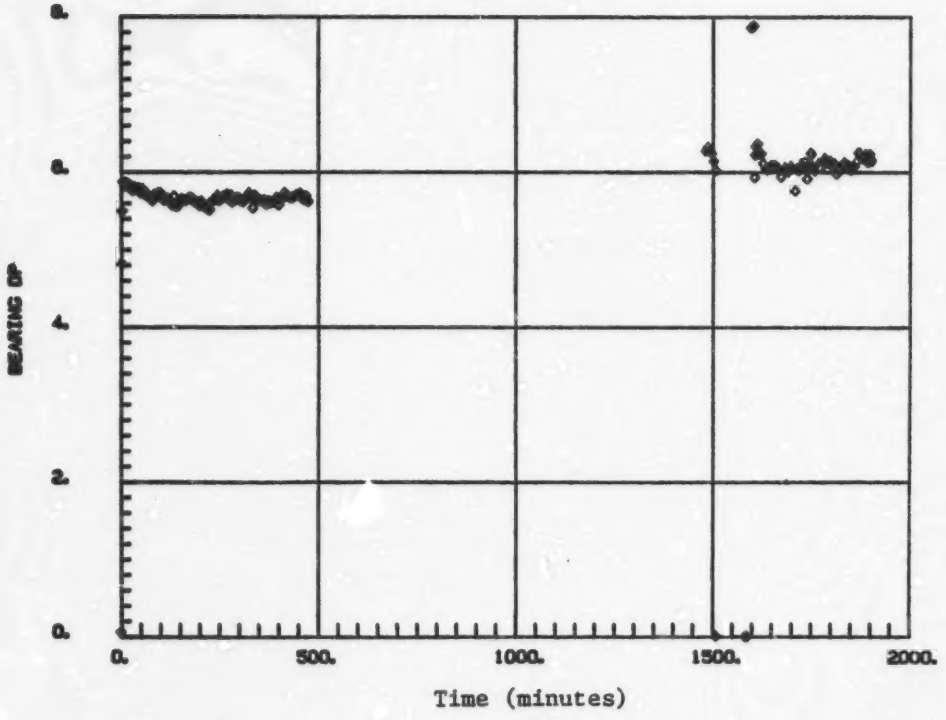
Figure 7-4 $\Delta P_{bearing}$ Operating Range

The steady state bearing ΔP (Figure 7-4) was relatively constant during the first three days. On 21 February 1984, the bearing check valve system was modified to improve the tuning, and thus the bearing supply pressure. The bearing pressure was increased from 5.7 to 6.1 Bar.

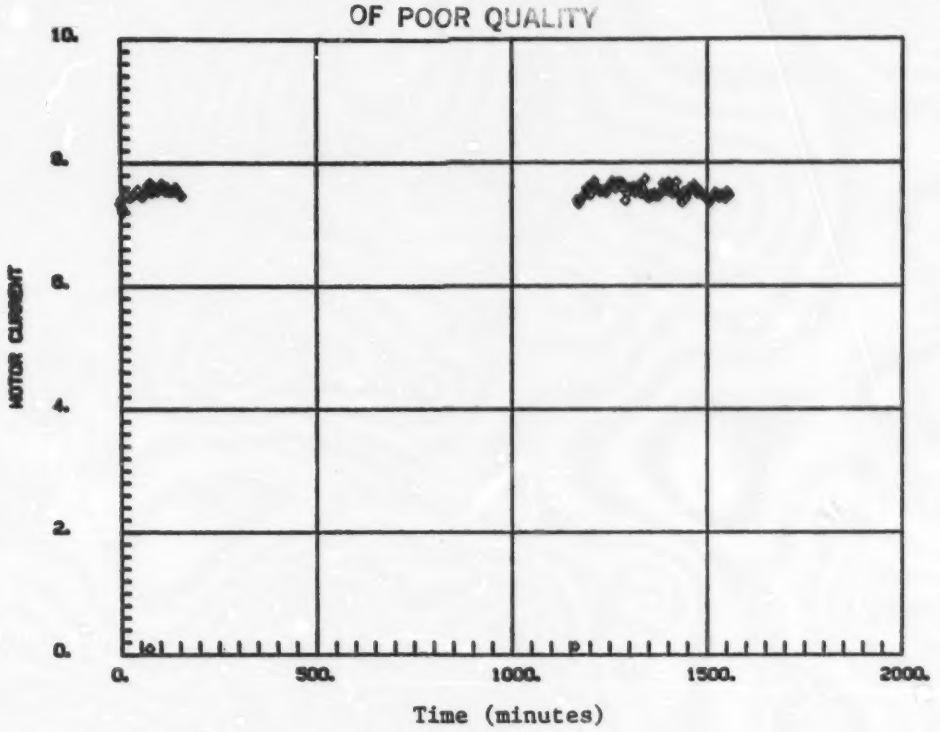
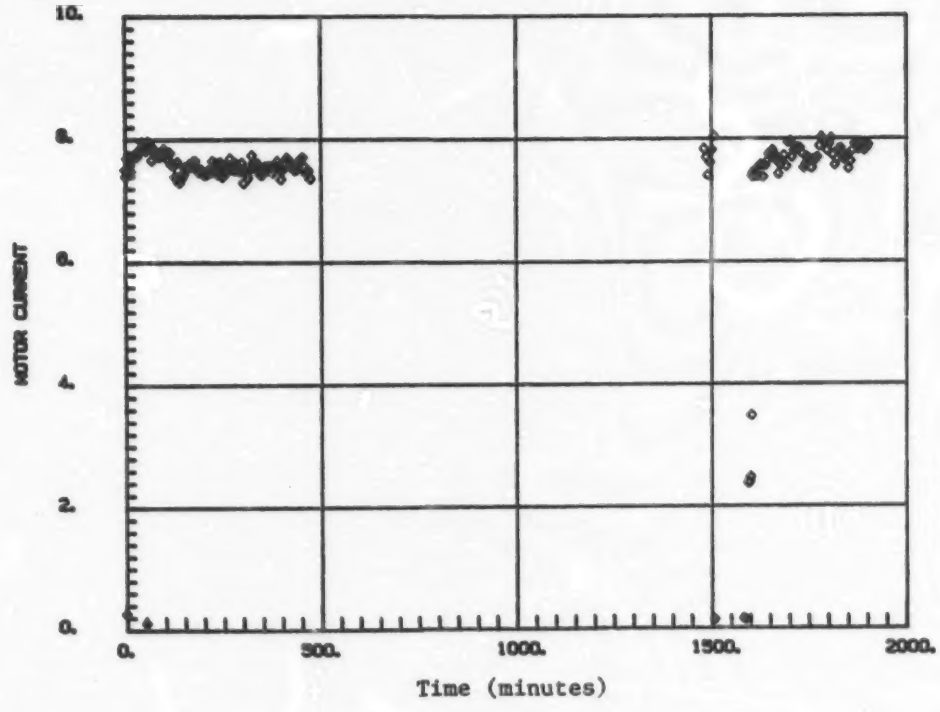
Figure 7-6 Displacer Motor Current Operating Rnage

The motor current (Figure 7-6) is proportional to the force that the motor imposes on the displacer and is the most sensitive to changes in dynamic or thermodynamic losses. This is evident by the scatter in the current during the first three days of testing compared to other parameters, such as piston and displacer amplitude. The data from 15 February 1984 indicates a potential increase in losses during the first hour of operation, after which the current dropped to the same as the previous two days of testing. The data from 21 February 1984 exhibits more scatter than was observed on 13-15 February 1984. This may be an indication of intermittent increases in losses which may be an early indication of engine degradation. Subsequent engine inspection indicated rubbing between the displacer rod and the bearing it runs in, and could explain the intermittent high current observed in the test data.
